Ceramic Liner Fracture after Ceramic-to-Ceramic Total Hip Replacement: A Case Report

Abstract

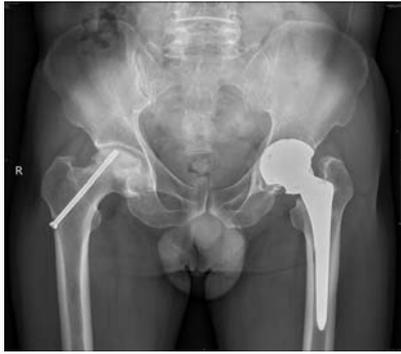
Figure 1: Preoperative radiograph. There was a ceramic liner fracture with a part of the broken liner protruding out of the cup.

1 year postoperatively. However, the patient had experienced pain on the left side since hearing a noise that occurred when he carried a heavy box 1 week previously. The patient had a significant hip pain and varying degrees of lameness, limited hip joint (the range of flexion extension was 0° to 90°). Radiographs revealed a ceramic liner fracture with a part of the broken liner protruding out of the cup (Figure 1).

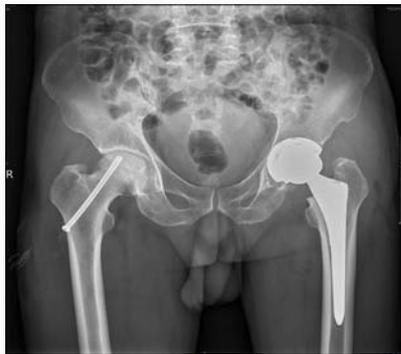
Figure 2: The plain radiograph of pelvis after initial THA. The ceramic liner was slightly out of the acetabular cup.

The pelvic radiographs were carefully analyzed by our surgery team. Enlargement of the pelvic radiographs taken immediately after the initial THA surgery showed that the ceramic liner was slightly out of the acetabular cup. Therefore, the major problem was the inaccurate placement of the ceramic liner in the initial surgery. Incorrect placement of the liner likely led to uneven forces on the liner and femoral head, resulting in fracture of the liner and wear of the ceramic head. This hypothesis was verified after the removal of the ceramic liner and head (Figure 2).

In the present case, the main reason for ceramic liner fracture was the wrong seating of the liner in the initial THA surgery. This highlights the fact that it is very important to follow the THA procedure strictly, especially for less experienced surgeons.

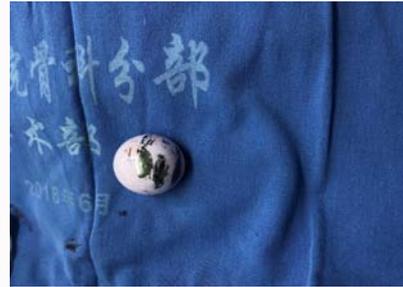
There was no loosening of the femoral component seen after the surgery site was reopened. The femoral prosthesis and acetabular cup were stable. The ceramic femoral head was unbroken and the bearing had worn edges (Figure 3). The ceramic liner was fragmented into three major parts, the fragmented edge of the liner had detached from the acetabular component, and there was widespread very small debris in the joint from the fragmented edge (Figure 4).

Figure 3: The ceramic femoral head removed from the patient. The bearing surface had worn severely.

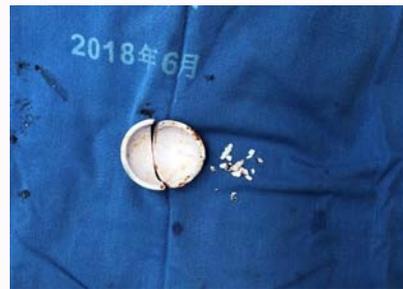
Figure 4: The ceramic liner removed from patient. The fragmented edge of the liner had detached from the acetabular component and the small debris from the fragmented edge were removed around the joint.

All fractured ceramic fragments were removed. A new ceramic head and ceramic liner of the same size as the original components were inserted. The seating of the liner was checked twice before femoral head restoration.

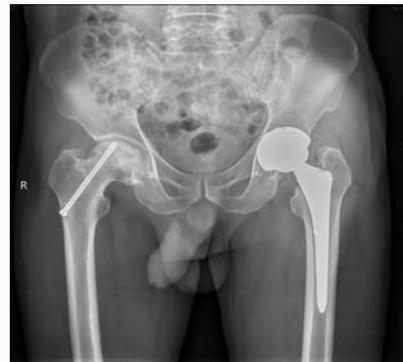
Figure 5: Radiograph after revision. The seating of the ceramic liner was good after revision.

The patient received professional rehabilitation training by the rehabilitation nurses, and the training included going to walk early, passive hip and knee bending, regular follow up. The patient did not have any further symptoms during 1 year of postoperative follow-up (Figure 5).

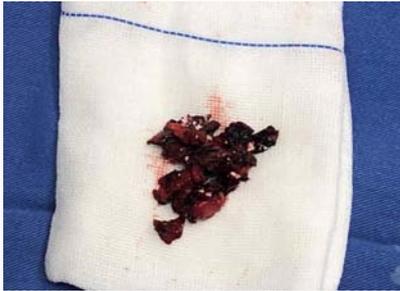
Figure 6: Soft tissue removed from patient. There were some tiny debris in the black soft tissue.

Fracture of ceramic THA materials leads to numerous complications [6]. The presence of many ceramic pieces around the joint capsule leads to foreign body reactions, as shown by the black soft tissue seen in the present case (Figure 6). It was necessary for our team to remove more of the joint capsule and more soft tissue, which will probably lead to dislocation in the future [9]. Furthermore, a new ceramic liner and head were needed to replace the original ones. Thus, the costs of revision surgery are high, which is not good for the patient and the healthcare system [10].
