Destabilization of the Comminuted Clavicle Shaft Fracture due to Breakage of the Titanium Locking Plate: Biomechanical Analysis

Abstract

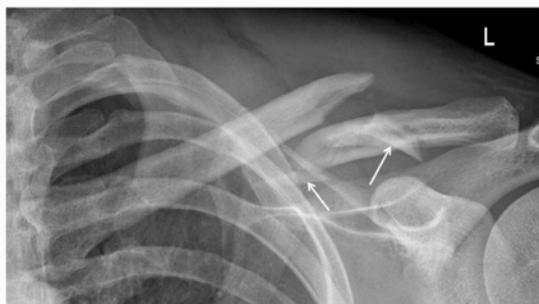
Figure 1: Preoperative x-ray revealing comminuted clavicle shaft fracture with two intermediate bone fragments (arrows).

A 33-years old, athletic male (105 kg body weight, 188 cm height) was operated on due to comminuted fracture of the shaft of the left clavicle (Robinson type II, B2; (Figure 1). Fracture was anatomically reduced and stabilized with 2.8 mm Ti-6Al-4V, precontoured, angle stable, locking plate (System 5.0, ChM, Poland) implanted on its superior surface. Both intermediate bone fragments were additionally fixed with titanium cortical screws (Figure 2). Postoperative wound healed uneventfully and patient was discharged with limb immobilized in shoulder brace for four weeks. After that, patient was referred to rehabilitation, but was recommended to avoid massive physical loads.

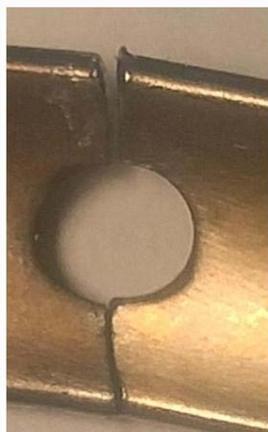
The explant was analyzed macroscopically excluding its manufacturing defect. Under magnification, the areas of brittle and fatigue fractures were identified (Figure 4). Interestingly, fatigue fracture was localized on the inferior part of its anterior branch, and brittle-on the posterior as well as inferior aspect of the anterior branch that was, additionally, curved anteriorly and inferiorly (Figure 5).

Figure 5: Inferior bending of the anterior and inferior edges of the anterior branch of the plate (dashed lines). Inferior aspect of the plate.

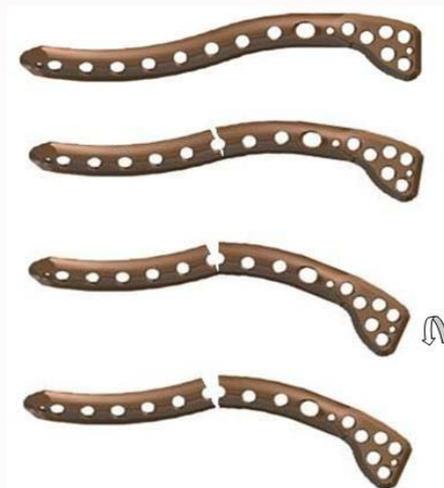
kN. But it could practically never occur. In vast majority of cases, the clavicle moves in transverse plane forward and backward, bending the plate at its hole and stretching its posterior branch, whereas the anterior one serves as a hinge. Under those conditions, the load of 580 N only is sufficient to break the plate, when acting on the acromioclavicular joint from its posterior aspect. Angulation of the antero-inferior edge of the plate supports this observation pointing out to the directions of loads that resulted in the break (Figure 6).

Figure 6: Schematic representation of the process of plate fracture from the superior (left) and postero-anterior views (right). Primarily, mechanical loads acting on the distal part of the plate resulted in brittle fracture of its posterior branch, than anterior one.

Moreover, orienting the plate to the patient's body it could also be concluded that the break was caused by a combination of multiaxial loads under stress conditions, resulting from simultaneous effect of tension, bending and torque. It clearly shows that the patient has not respected the post-operative recommendations to avoid overloads.

In the presented case the most probable loads that resulted in plate break off acted in the transverse plane, stretching the posterior branch of the plate, whereas the anterior branch served as a hinge and plate width as a lever. Under those conditions the moment of the force that deforms permanently the plate was validated to be 12,8 Nm, and it corresponds to that theoretically estimated. Thus, both theoretical and experimental investigations showed that loads of 160 N (for instance raising the weight of 16 kg from the ground) acting over the plate in transverse plane over the shoulder from its posterior aspect, is sufficient to deform it permanently.
