Use of Hip Resurfacing after Renal Transplantation: A Case Report

Abstract

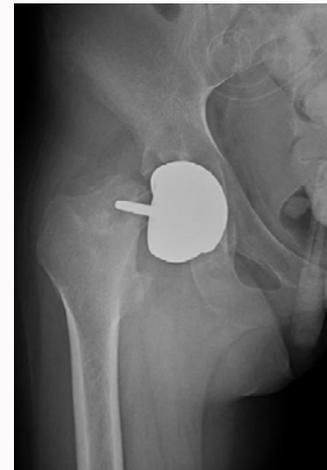
Figure 4: Periprosthetic fracture on unsealed prosthesis of the right hip after a banal trauma.

In January 2014, common trauma caused periprosthetic fracture of the right femoral neck (Figure 4) requiring immediate surgical revision. During the surgical revision, we found a very thick and blackened joint capsule. The articular cavity was filled with dark gray granulomatous tissue. This hypertrophic tissue was present not only around the neck of the femur and the acetabulum but also below the cup, destroying in this way the upper and posterior edge of the acetabulum. An un-cemented cup with a ceramic coating, fixed by two screws, was put in place. Osteolytic acetabular lacunae were filled with fractured bone grafts (freeze-dried bone) from the bone bank. The femoral part was taken up by a non-cemented stem (Avenir, Zimmer, Belgium) with a ceramic head 32 mm in diameter (Figure 5).
