Use of Hip Resurfacing after Renal Transplantation: A Case Report

Abstract

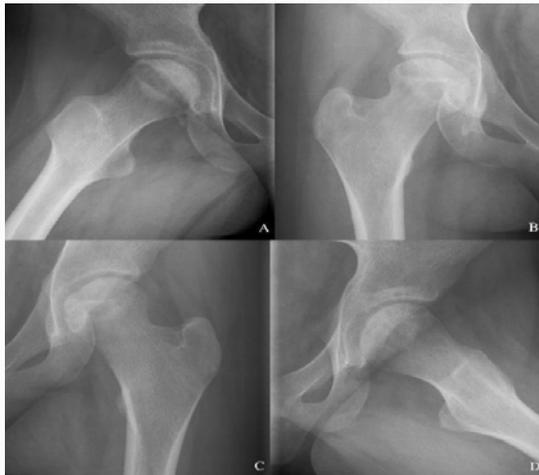
Figure 1: Bilateral necrosis of the femoral heads. Lateral image (A) and AP (B) of the right hip. AP (C) and lateral (D) radiographs of the left hip. All images are characteristic of necrosis of the femoral head.

In 2007, the patient complained of bilateral pain in her hips that was becoming increasingly disabling. Radiological examinations revealed bilateral necrosis of the femoral heads (Figure 1). Considering the age of the patient, stem cell therapy was attempted, unsuccessfully, most probably due to the ongoing immunosuppressive therapy.

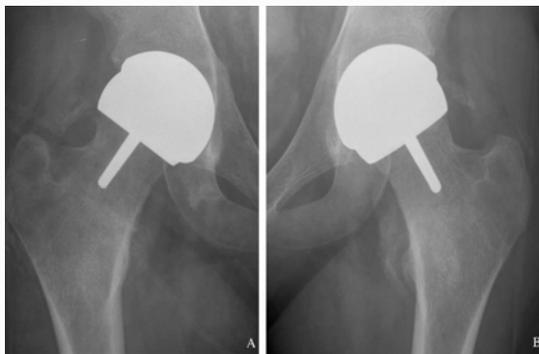
Figure 2: Immediate control of the resurfacings of the two hips with De Puy ASR™, Co-Cr alloy with a 41 mm friction torque in caliber.

After the failure of the stem cell therapy in January 2008 at the age of 19, hip resurfacing was performed: first on the right side, and 3 months later on the left side, using a metal-to-metal prosthesis with a head of 41 mm in diameter (Figure 2).

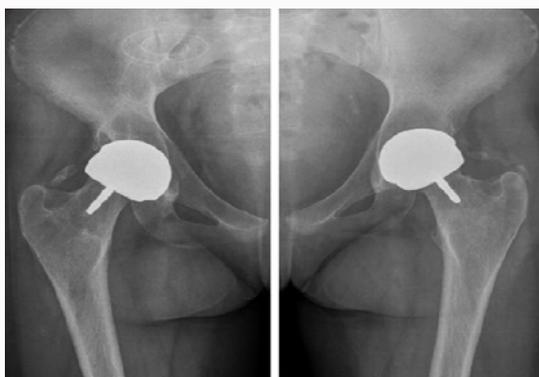
Figure 3: Two-year control of resurfacing. Radiography of the two hips revealed several lacunar lesions (osteolysis) in the right acetabulum, thinning both of the femoral neck and periprosthetic ossification.

The clinical examination conducted at the end of 2013 revealed a strongly painful limitation of hip movements bilaterally, especially during internal rotation. Radiography of both hips revealed several lacunar lesions (osteolysis) at the right acetabulum, thinning of both femoral necks, and periprosthetic ossifications. The examination raised the possibility of pseudo tumor formation in both hips (but more so on the left side), that may be in concordance with metal lose-related periprosthetic granulomas causing loosening (Figure 3).

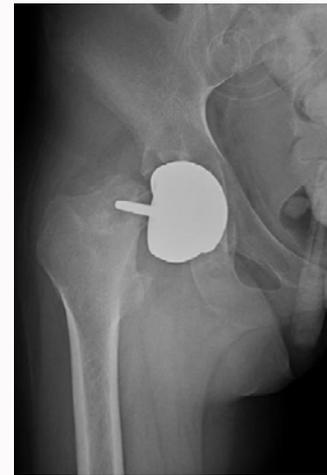
Figure 4: Periprosthetic fracture on unsealed prosthesis of the right hip after a banal trauma.

In January 2014, common trauma caused periprosthetic fracture of the right femoral neck (Figure 4) requiring immediate surgical revision. During the surgical revision, we found a very thick and blackened joint capsule. The articular cavity was filled with dark gray granulomatous tissue. This hypertrophic tissue was present not only around the neck of the femur and the acetabulum but also below the cup, destroying in this way the upper and posterior edge of the acetabulum. An un-cemented cup with a ceramic coating, fixed by two screws, was put in place. Osteolytic acetabular lacunae were filled with fractured bone grafts (freeze-dried bone) from the bone bank. The femoral part was taken up by a non-cemented stem (Avenir, Zimmer, Belgium) with a ceramic head 32 mm in diameter (Figure 5).

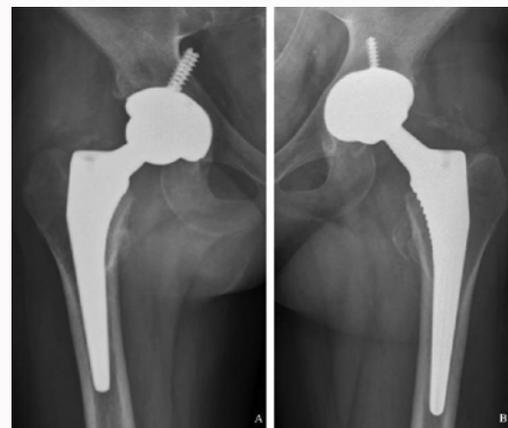
Figure 5: Immediate control of THA of both hips with un cemented stems (Avenir, Zimmer, Belgium) with ceramic heads 32 mm in diameter.

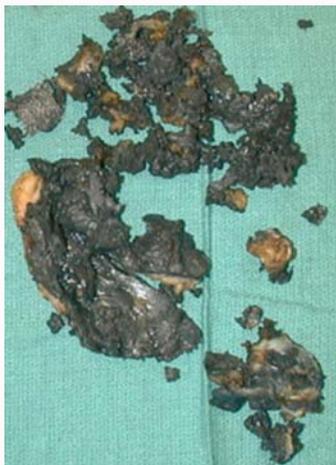
Due to the severe metallosis detected during the revision, a blood test for chromium and cobalt metal ions was performed. The chromium blood level was 49.93 µg/L – 25 times higher than the normal maximum value. For cobalt blood level, the measured value was 7.68 µg/L – 17 times higher than the normal maximum blood level (for the method used, the normal level of chromium is 0.12-2.1 µg/L; and for cobalt, 0.0-0.45 µg/L).

Figure 6: Tissues collected during the first revision with massive macroscopic metallosis.

Based on the patient's history and elevated blood chromium and cobalt levels, the patient received a revision of her total left hip replacement three months after revision of her total hip arthroplasty

(Figure 6). Three months after the second revision, chromium, and cobalt levels had already significantly decreased (chromium: 20.8 $\mu\text{g/L}$; cobalt: 1.59 $\mu\text{g/L}$). Since 2015, the blood level of heavy metals has remained normal (chromium: below 2 $\mu\text{g/L}$; cobalt: below 0.45 $\mu\text{g/L}$).

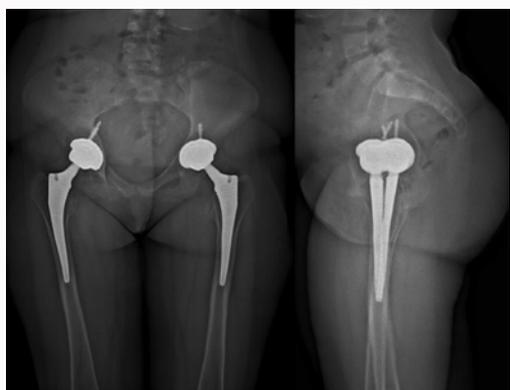
Figure 7: Last PTH check with EOS.

Currently, the patient is well, with complete hip movement on both sides. She walks without a limp and without pain. The last EOS examination (Figure 7) showed perfect equality of both lower limbs without evidence of prosthesis loosening. In 2015, the patient had a third kidney transplant that works very well now, as shown by the last renal assessment of April 2018 (urea: 34 mg/mL; creatinine: 0.79 mg/mL; GFR: 110 mL/min/L; 73 m^2).
