## Destabilization of the Comminuted Clavicle Shaft Fracture due to Breakage of the Titanium Locking Plate: Biomechanical Analysis

Szczęsny G, Kowalewski Z. Destabilization of the Comminuted Clavicle Shaft Fracture due to Breakage of the Titanium Locking Plate: Biomechanical Analysis. *Clin Surg.* 2018; 3: 2125.

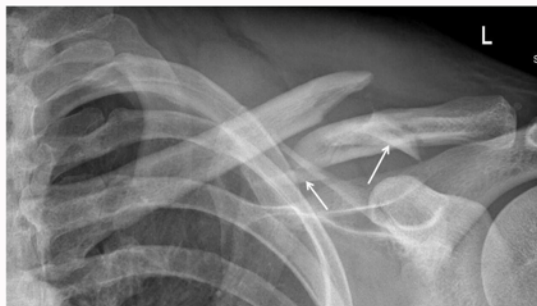
**Figure 1:** Preoperative x-ray revealing comminuted clavicle shaft fracture with two intermediate bone fragments (arrows).

A 33-years old, athletic male (105 kg body weight, 188 cm height) was operated on due to comminuted fracture of the shaft of the left clavicle (Robinson type II, B2; (Figure 1). Fracture was anatomically reduced and stabilized with 2.8 mm Ti-6Al-4V, precontoured, angle stable, locking plate (System 5.0, ChM, Poland) implanted on its superior surface. Both intermediate bone fragments were additionally fixed with titanium cortical screws (Figure 2). Postoperative wound healed uneventfully and patient was discharged with limb immobilized in shoulder brace for four weeks. After that, patient was referred to rehabilitation, but was recommended to avoid massive physical loads.

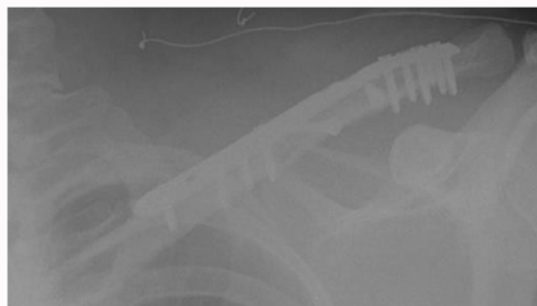
**Figure 2:** Postoperative X-ray.

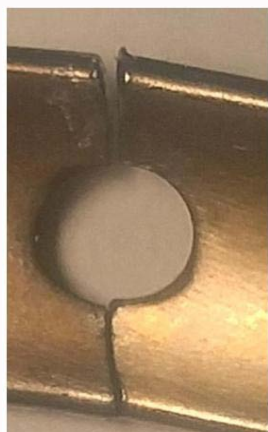
**Figure 5:** Inferior bending of the anterior and inferior edges of the anterior branch of the plate (dashed lines). Inferior aspect of the plate.

The explant was analyzed macroscopically excluding its manufacturing defect. Under magnification, the areas of brittle and fatigue fractures were identified (Figure 4). Interestingly, fatigue fracture was localized on the inferior part of its anterior branch, and brittle-on the posterior as well as inferior aspect of the anterior branch that was, additionally, curved anteriorly and inferiorly (Figure 5).

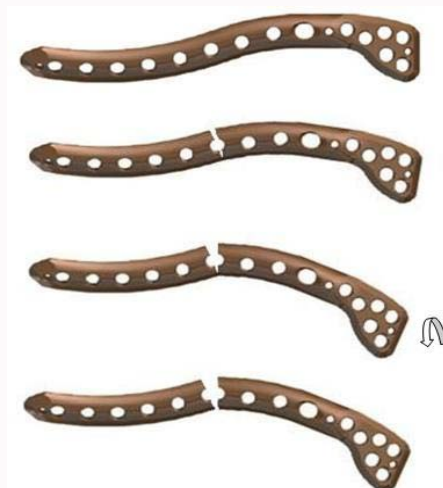
**Figure 6:** Schematic representation of the process of plate fracture from the superior (left) and postero-anterior views (right). Primarily, mechanical loads acting on the distal part of the plate resulted in brittle fracture of its posterior branch, than anterior one.

kN. But it could practically never occur. In vast majority of cases, the clavicle moves in transverse plane forward and backward, bending the plate at its hole and stretching its posterior branch, whereas the anterior one serves as a hinge. Under those conditions, the load of 580 N only is sufficient to break the plate, when acting on the acromioclavicular joint from its posterior aspect. Angulation of the antero-inferior edge of the plate supports this observation pointing out to the directions of loads that resulted in the break (Figure 6).

Moreover, orienting the plate to the patient's body it could also be concluded that the break was caused by a combination of multiaxial loads under stress conditions, resulting from simultaneous effect of tension, bending and torque. It clearly shows that the patient has not respected the post-operative recommendations to avoid overloads.
