Massive Aortic Sac Aneurysm Following Open Surgery Treated With Percutaneous Drainage: A Case Report

Jerry Matteo* and Brian Rhodes

Department of Radiology, Division of Vascular and Interventional Radiology, University of Florida College of Medicine-Jacksonville, USA

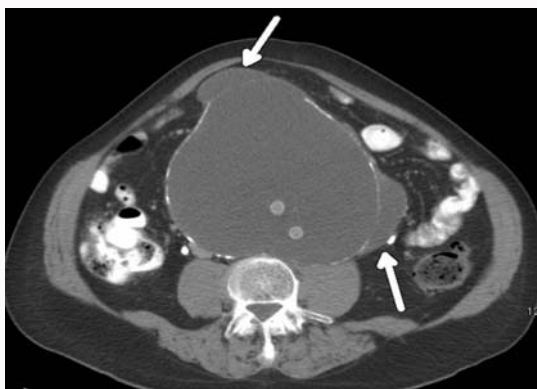
Figure 3: Shows two areas of contained ruptures anterior and lateral (arrows).

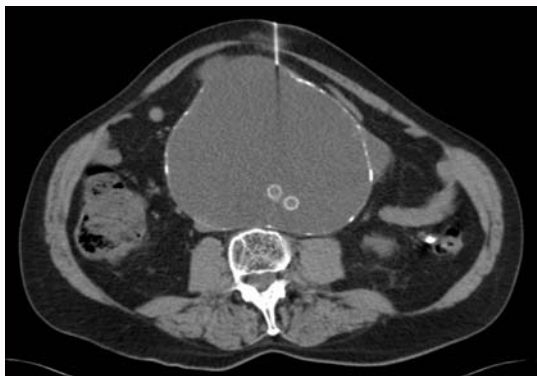
Figure 4: Show a 19-gauge percutaneously inserted to puncture the native aortic sac under CT guidance.

The patient is a symptomatic 62 year-old male with shortness of breath and abdominal pain was found to have a rapidly enlarging aneurysm sac on a contrast enhanced computed tomography (CT) scan without evidence of an endoleak or contrast extravasation (Figure 1). The patient had an open surgical repair of a prior abdominal aortic aneurysm (AAA) 12 years ago. The native aorta has increased in size to 18 cm in diameter from 10 cm in just three years and shows several areas of small-contained rupture (Figure 2 and 3). Following discussions with the patient and vascular surgery, the decision was made to sample the fluid from a percutaneous approach and perform drainage of the sac to relieve his symptoms. The patient was placed supine on the CT table. Following the initial scout images, a safe anterior site on the abdomen was marked, prepped and draped in the usual sterile fashion. A 19-gauge Biopince needle (Angiotech Pharmaceuticals, Inc., Vancouver, BC, Canada) was used to puncture the native aortic sac under CT guidance (Figure 4). 30 ml of straw colored fluid was aspirated and sent to Pathology for gram stain evaluation (Figure

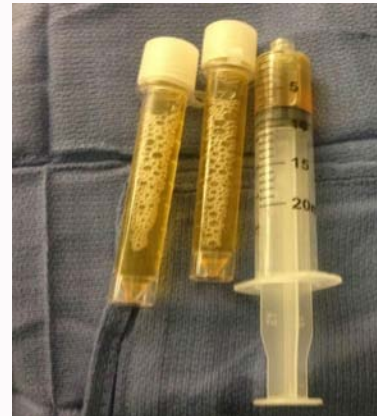
Figure 5: Shows 30 ml of straw colored fluid aspirated from the AAA sac.

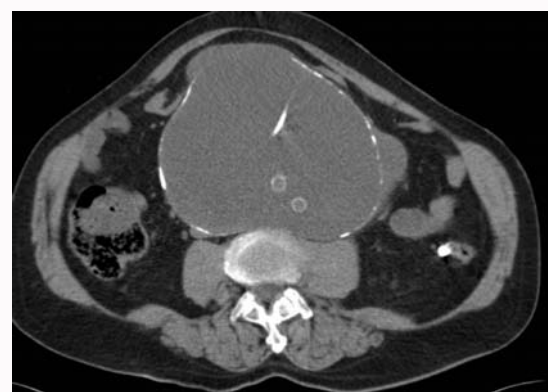
Figure 6: Shows a drainage catheter advanced over the wire into the posterior aspect of the aortic sac fluid collection.

5). Following this, a Bentson guide wire (Boston Scientific, Natick, MA) was inserted through the needle and a 6 French Skater drainage catheter (Angiotech Pharmaceuticals, Inc., Vancouver, BC, Canada) was advanced over the wire into the posterior aspect of the aortic sac fluid collection (Figure 6). 1500 ml total fluid was removed with only minimum residual remaining (Figure 7 and 8). The catheter was then removed and a sterile bandage was placed. The patient tolerated the procedure without any immediate complications. Following successful CT guided percutaneous drainage of the sac, which yielded sterile uninfected serous fluid, there was immediate symptomatic relief and the patient continues to do well. The patient was seen in clinic one year later without imaging; however he continues to remain

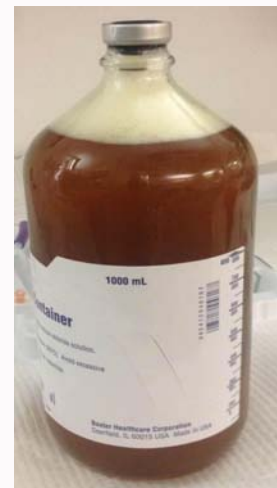
Figure 7: Shows container of the contents of the AAA sac after drainage.

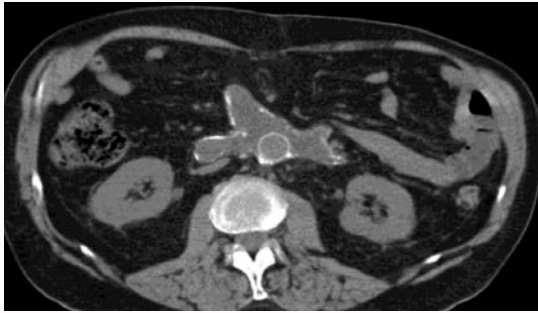
Figure 8: Shows an axial CT of the AAA sac following percutaneous drainage slightly superior to the limbs of the surgical aortic bi-femoral bypass. This demonstrates the only significant residual fluid remaining and also shows the redundancy of the aortic sac.
