Postoperative Infection Caused by a Resorbable Plate used to Treat a Zygomatic Fracture

Sukegawa S^{1*}, Kanno T^{1,2}, Kawai H³, Shibata A¹, Sukegawa-Takahashi Y¹ and Furuki Y¹

¹Division of Oral and Maxillofacial Surgery, Kagawa Prefectural Central Hospital, Japan

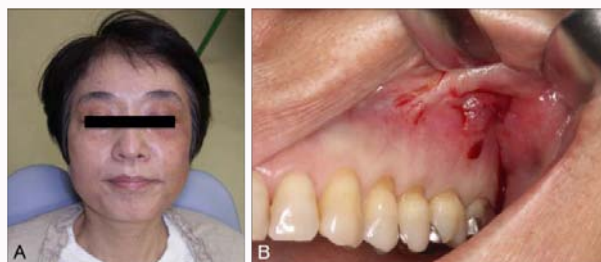
Figure 1: (A) Slight facial asymmetry observed on the left side of the face. (B) Intraoral photographs showing the fistulae connected with the maxilla zygoma in the gingivobuccal area of the left maxilla.

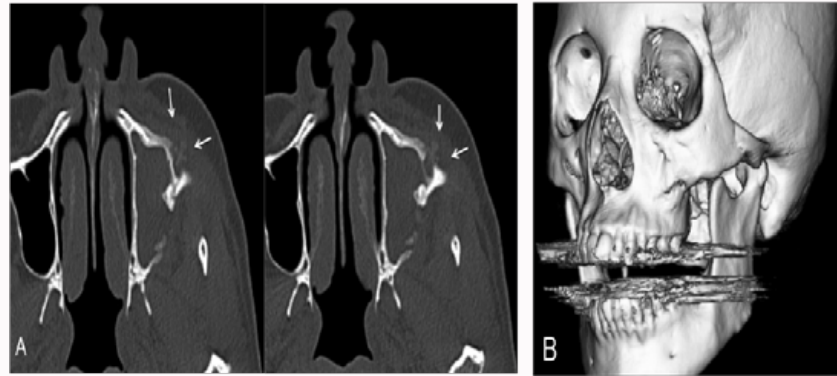
Figure 2: Computed tomography images. (A) Axial soft tissue window image showing a cystic lesion, extending from the left maxillary alveolar area to the maxillary sinus. (B) The fracture had sufficiently recovered; however, the zygomaticomaxillary bone surrounding the plate was absorbing it.

in the left cheek. Five months earlier, the patient underwent surgery to fit a Lactosorb® 1.5 resorbable fixation system (Lorenz Surgical, Jacksonville, FL, USA) to fix a zygomatic bone fracture at another general hospital. The patient never suffered any discomfort or presented any problems in the operative site before the fracture. Osteosynthesis was achieved by a fixation technique using three points along to the orbital rim, the frontozygomatic suture, and the zygomaticomaxillary buttress. During her first visit to the general dental practitioner, an intraoral examination revealed the presence of pus, discharged from the gingivobuccal area (Figure 1). Furthermore, a probe showed that the bone could be easily reached. A maxillofacial computed tomographic scan taken during the first visit showed as swelling of the soft tissue next to the left maxillary sinus and a maxillary sinusitis. In addition, the plate at the zygomaticomaxillary buttress showed bone resorption surrounding the plate and the screws (Figure 2).

These clinical symptoms did not improve after initial treatment with Clarithromycin for 2 weeks, followed by Cefcapenepivoxil hydrochloride hydrate for 2 weeks together with continuous local irrigation. Based on these symptoms the patient was diagnosed with an infection caused by the fitted resorbable plate and screw, and the full removal of biomaterials was recommended. The patient was operated to remove the plate and the screws under local anesthesia. The operation involved a vestibular incision on the left side of the mandible to locate and remove the free resorbed plate and the screws on the buttress. In addition, the operative team cleaned the area of bone resorption surrounding the bioresorbable plate and the maxillary sinus front wall for abscess formation of the maxillary sinus (Figure 3). During the operation, we took samples from the affected area; *Streptococcus milits* and anaerobic bacteria were cultured from these

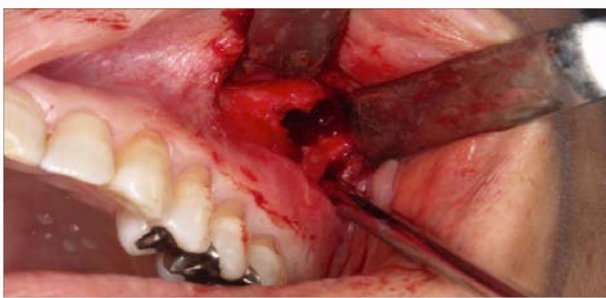
Figure 3: Bone resorption surrounding the extracted plate continued toward the maxillary sinus.

progressed as expected. The severe inflammation reaction observed could have led to periimplant osteolysis. In addition, the mobility of the plate and the screw as a result of the bone resorption could have further exacerbated the maxillary infection. A buccal buttress requires an occlusal stress. Resorption of a plate progresses 5 months postoperatively and the plate strength decreases. Because an occlusal force is recovered 2 months postoperatively for zygomatic fractures [15], it may lead to instability of a plate by a strong occlusal stress. Therefore, during zygomatic fracture treatment, we have to consider buccal buttress of the resorptive plate in which strength temporally reduces. To prevent the plate surge by an incongruity, it is required to firmly fit a plate to a bone.

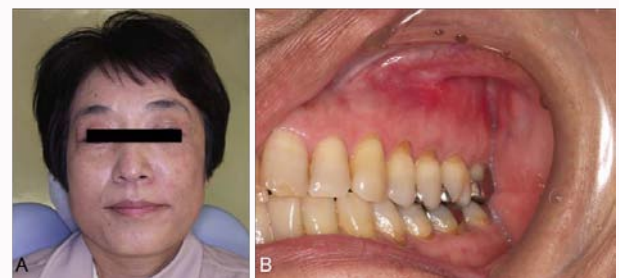
Figure 4: (A) Postoperative findings of the patient 3 months after surgery showing no evidence of swelling. (B) Intraoral photographs showing no fistula the healing of normal mucosa.

samples. The patient reported an immediate relief of the symptoms after the operation, and no evidence of infection was detected after 3months of follow-up.
